# Shoreline Erosion Management Plan – Final Report

## Hinchinbrook Shire SEMP

Hinchinbrook Shire Council

11 August 2023

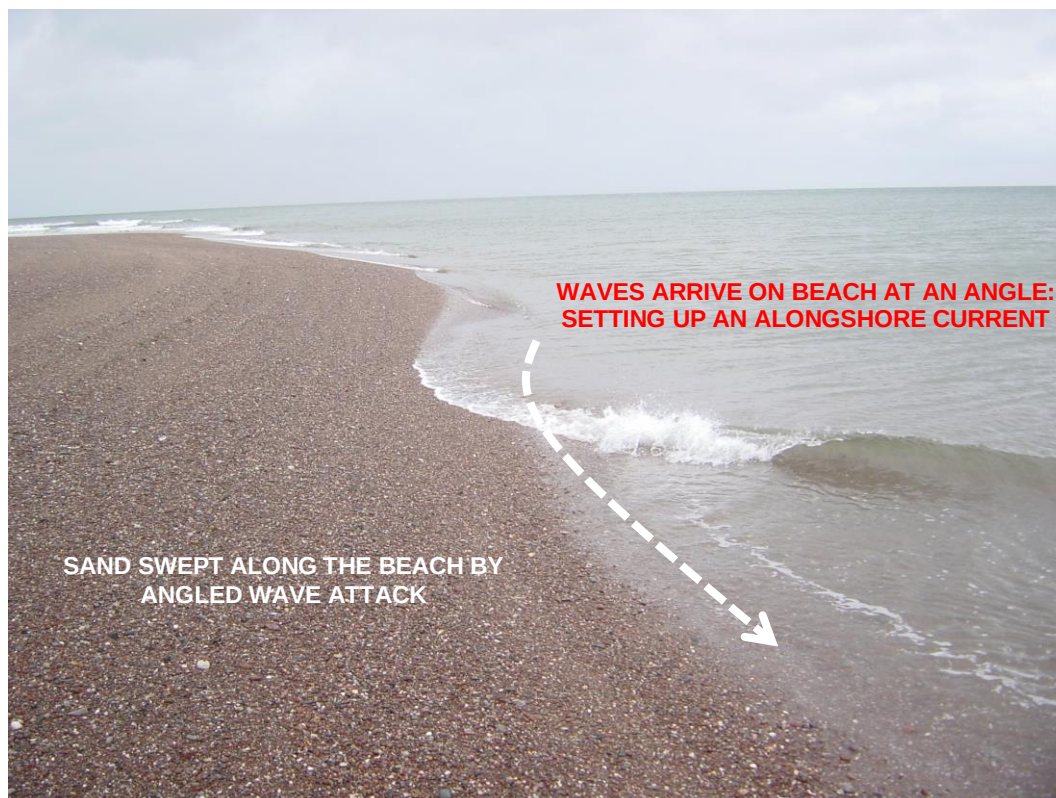
Waves arriving with their crests angled from the shoreline alignment create an alongshore current that initiates and maintains sediment transport along the beach. While the nearshore wave misalignment and wave height may appear small, the relentless wave action and episodic storms account for substantial volumes of sand moved annually.

Figure 3-27 Longshore Sediment Transport

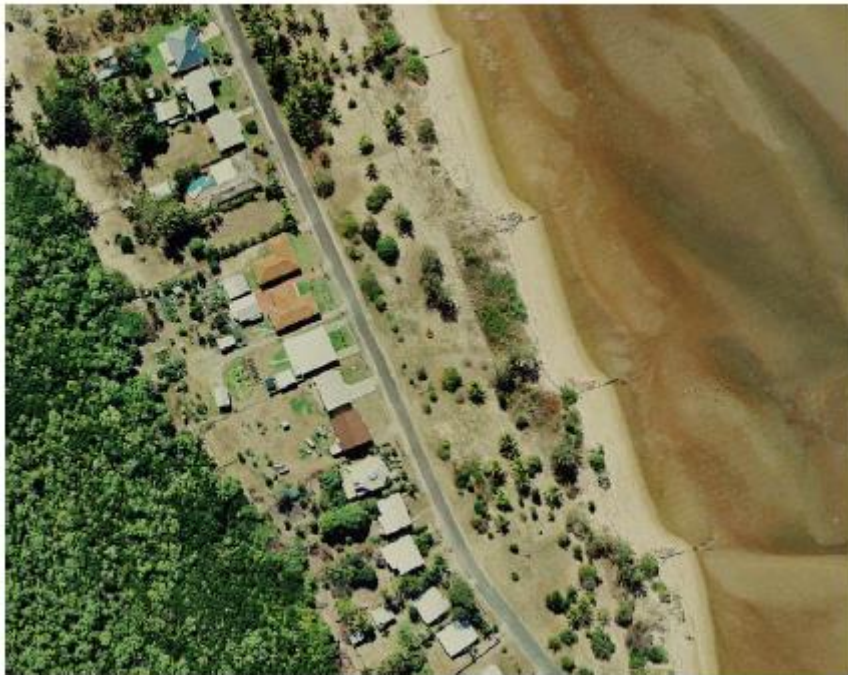
The net longshore transport along the Hinchinbrook coastline is northwards and is driven by the predominant south-easterly wind and wind-waves. The Lucinda Spit alignment and the beach alignment around the groyne structures along Patterson Parade demonstrate that sand is typically flowing northward on the open coast, as shown in Figure 3-28.

**Figure 3-28 Sediment deposition at Lucinda Groyne Field**

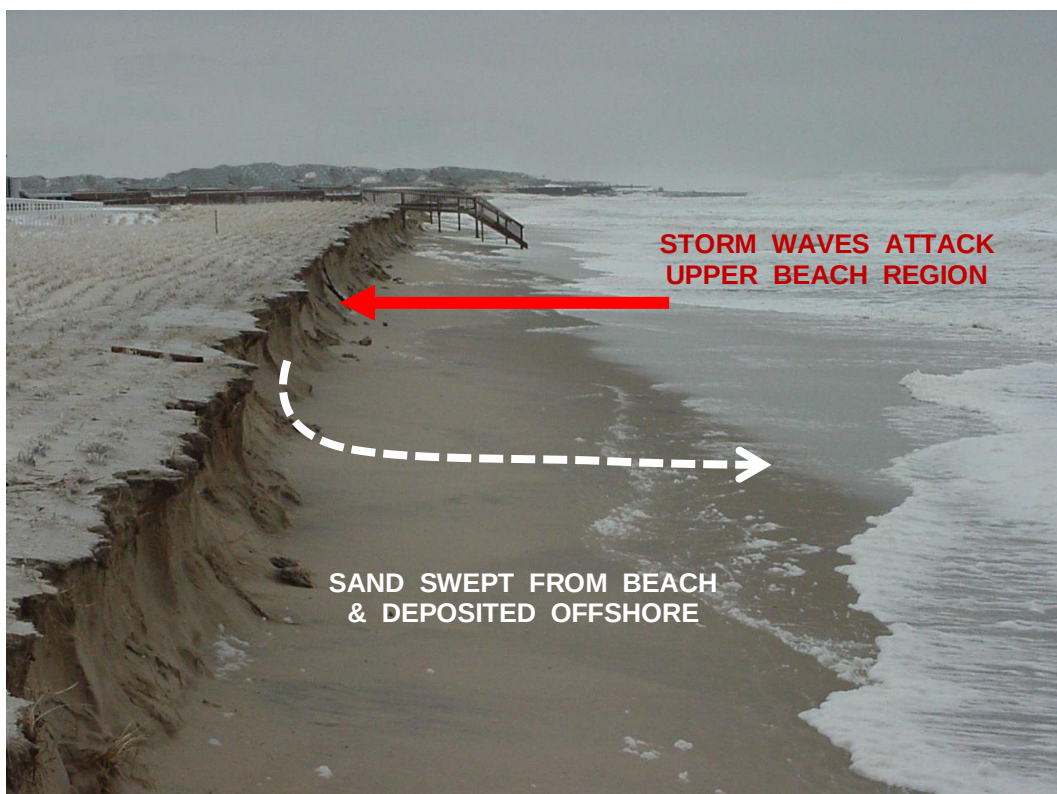
Strong wave action and elevated ocean water levels during storms can cause severe beach erosion when sand is removed from the dunes and upper regions of the profile and deposited in a nearshore sandbar. Storm beach erosion is also called storm bite. Coastal erosion can threaten or damage foreshore infrastructure when the storm or cyclone is particularly severe. However, the sand is not lost. Instead, the dune and upper beach sand is moved offshore into the surf zone. Mild wave conditions return this sand onto the intertidal beach, where wave run-up and onshore winds can rebuild berm and dunes over time. Cross-shore beach erosion often occurs in a few hours, while the recovery of the beach berm and dunes can take many years.

**Figure 3-29 Cross-shore Sediment Transport – storm bite**

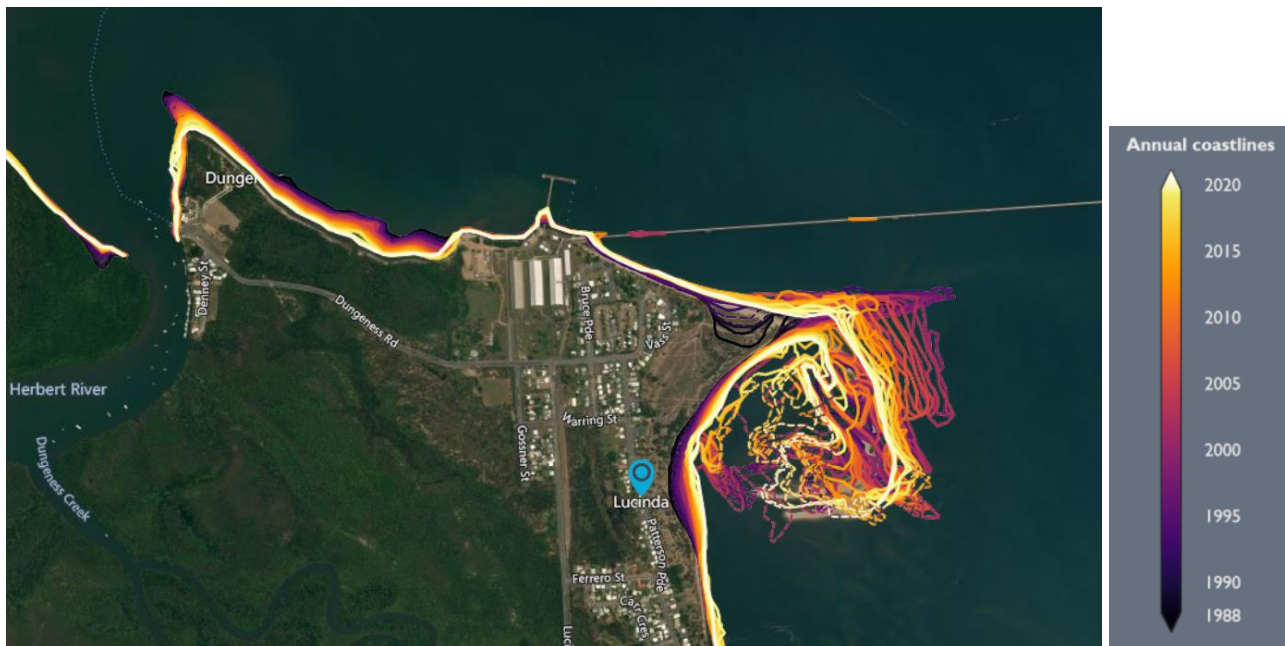
- From 2002-2020, the spit has developed a second hook that runs back from west to east - giving it a “o” shape. During this period, the spit has been migrating back towards the shore. As a result, the spit is reattaching to the subaerial beach at Lucinda. The alongshore sediment transport will be restored (to a certain degree) towards the Dungeness beach when this occurs.

**Figure 3-30 Shoreline Change at the Lucinda and Dungeness Spits from 1988 – 2020**

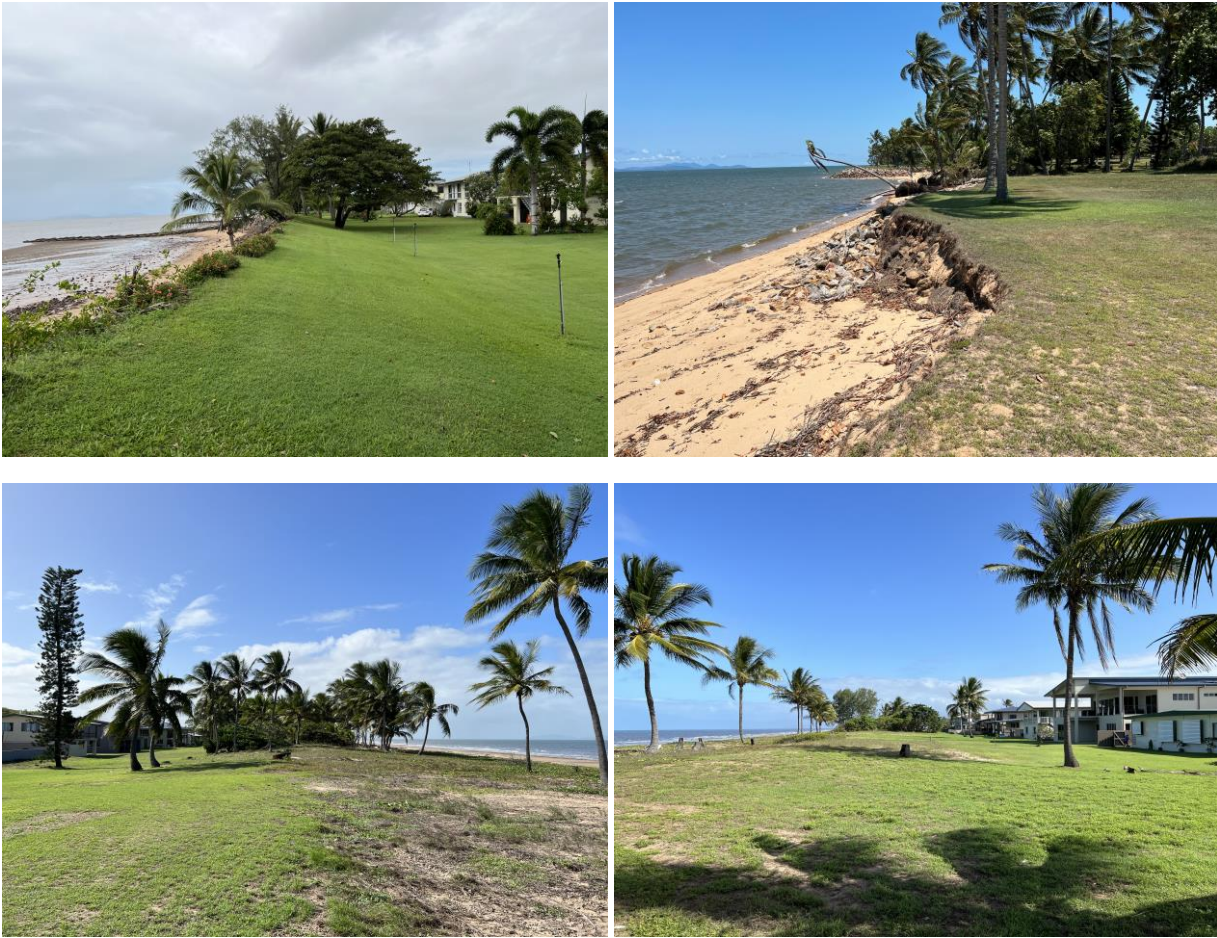
- Sand is moved downhill on bare slopes, lowering dune crests and infilling depressions. Blow-outs may occur where deep wheel ruts cross dune crests.
- Physical damages occur to plants above and below ground, impeding the regeneration and growth of new plants that are sensitive to disturbance.
- **Vegetation vandalism:** The intentional damaging of coastal vegetation is akin to environmental vandalism. It impacts the stability of dunes and their essential role in our coastal environment. Also, if an area of vegetation is damaged or removed, erosion becomes more susceptible. This can lead to a 'blow out' or gap in the dune. This gap can quickly grow and erode the rest of the dune system, impacting nearby properties and infrastructure.

**Figure 3-35** Examples of a lack of appropriate native dune vegetation at the study area. Top: Lucinda foreshore. Bottom: Forrest Beach

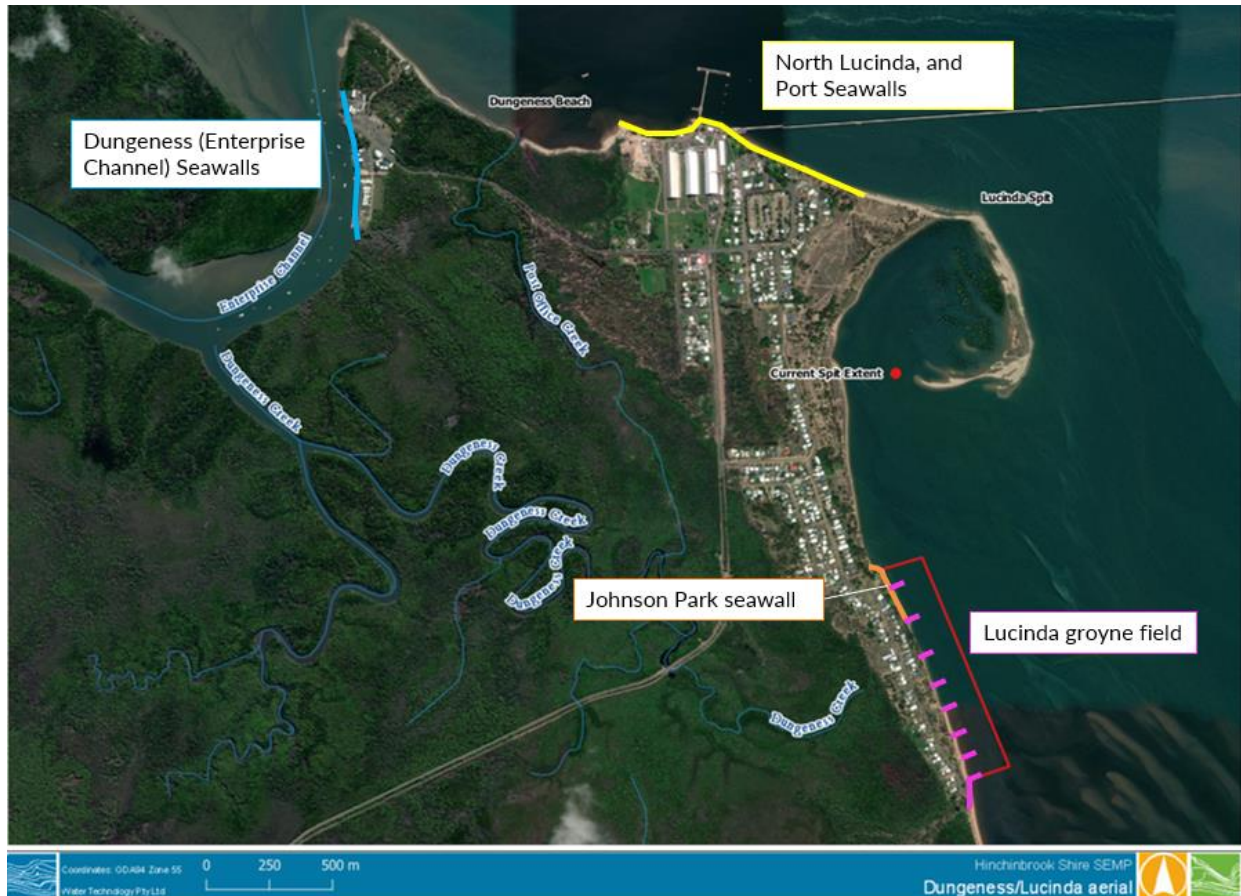
The layout of the various protection structures along Dungeness and Lucinda are provided in Figure 4-1, with additional detail provided below.

Figure 4-1 Coastal Protection Structures at Lucinda and Dungeness

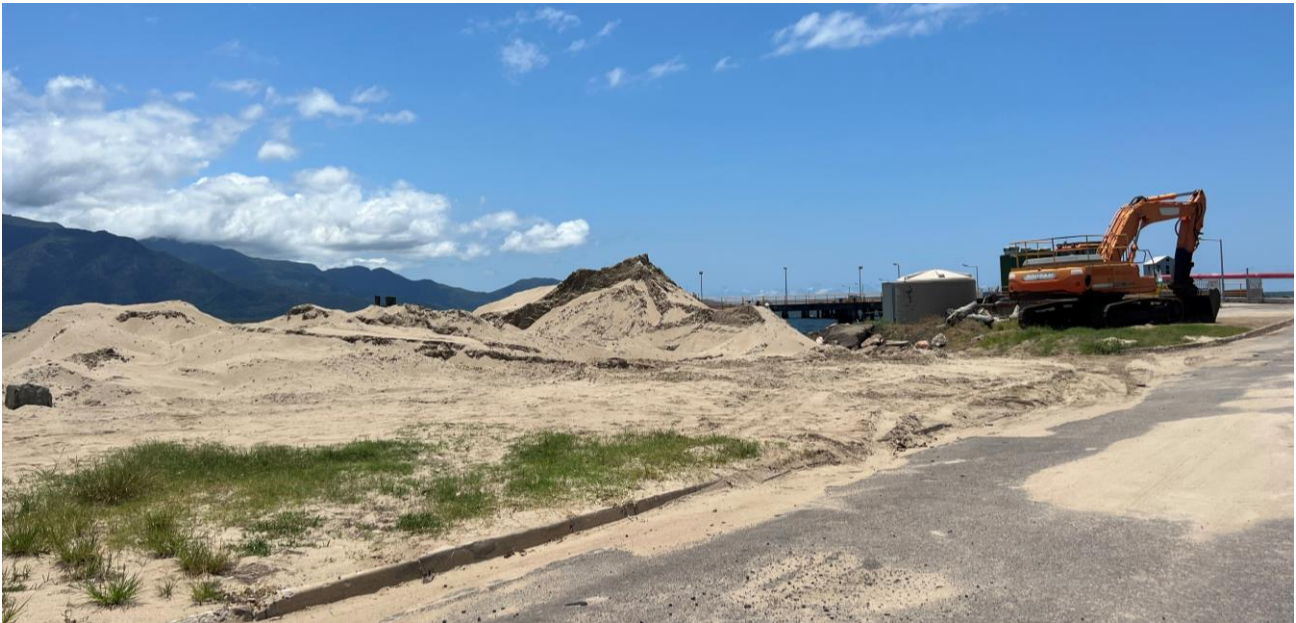
The sand is stockpiled adjacent to the ramp and then returned to the system upstream, at Dungeness Beach, at the Western end of the Port boundary.

**Figure 4-2 Dredge sand stockpiling at Lucinda Barge Ramp**

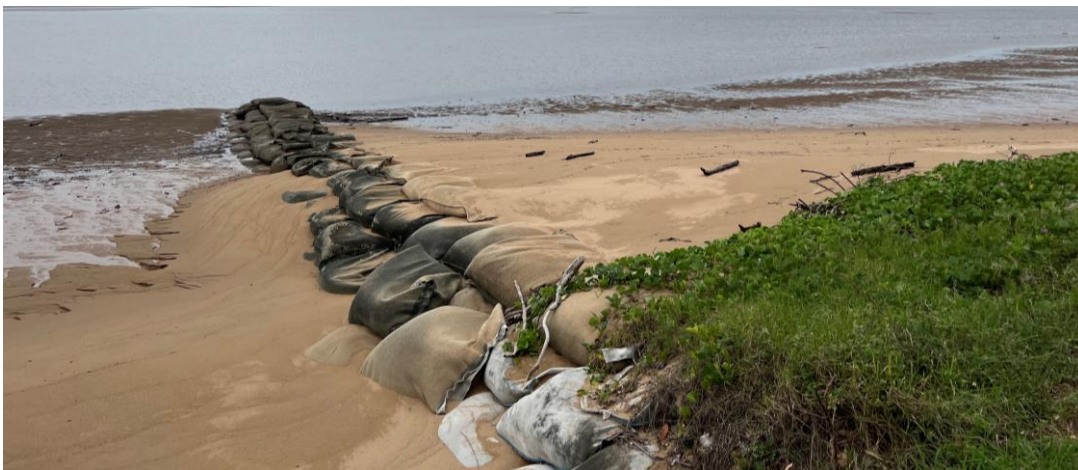
The beach level on the southern (i.e. updrift) side of most of the groynes is generally levelled with the crest of the structures, whilst the beach level on the northern (i.e. downdrift) side is generally notably lower – see Figure 4-3. This indicates that the sediment trapping capacity under ambient conditions has been reached, and that sediment routinely bypasses or overtops the groynes (BMT, 2009).

Figure 4-3 GSC Groynes at Lucinda, in 2022

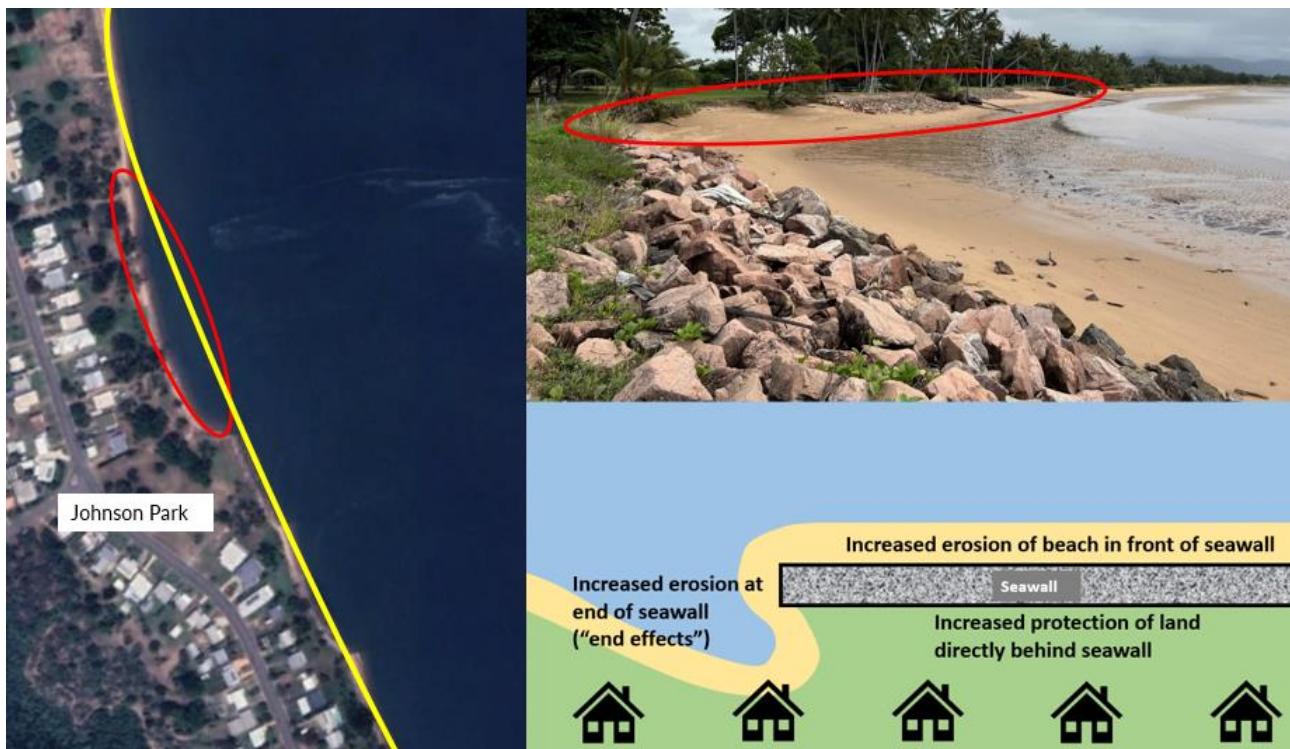
Also, significant terminal scour has occurred immediately downdrift of the northernmost revetment (a lawful Council structure) that protects Johnson Park – see Figure 4-4. The shoreline movement assessment by BMT WBM (2009) indicates that this terminal scour pocket has been a feature on the shoreline since at least 1971. At present, the end effects are damaging the seawall through outflanking.

Figure 4-4 Terminal Scour Observed at the downdrift (northern) end of the Johnson Park Seawall

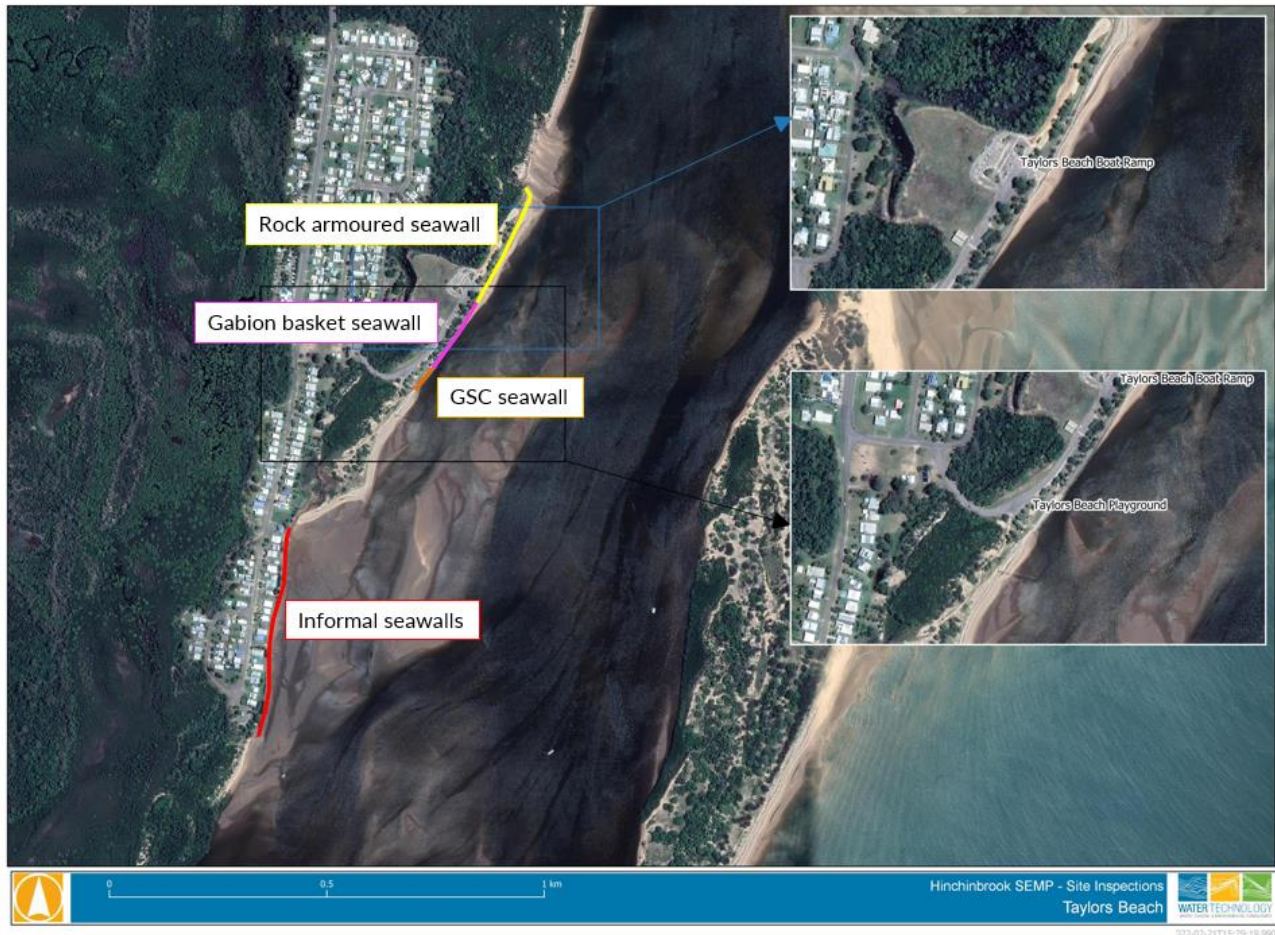
Figure 4-5 localises the coastal protection assets along Taylors Beach.

**Figure 4-5 Coastal Protection Structures at Taylors Beach**

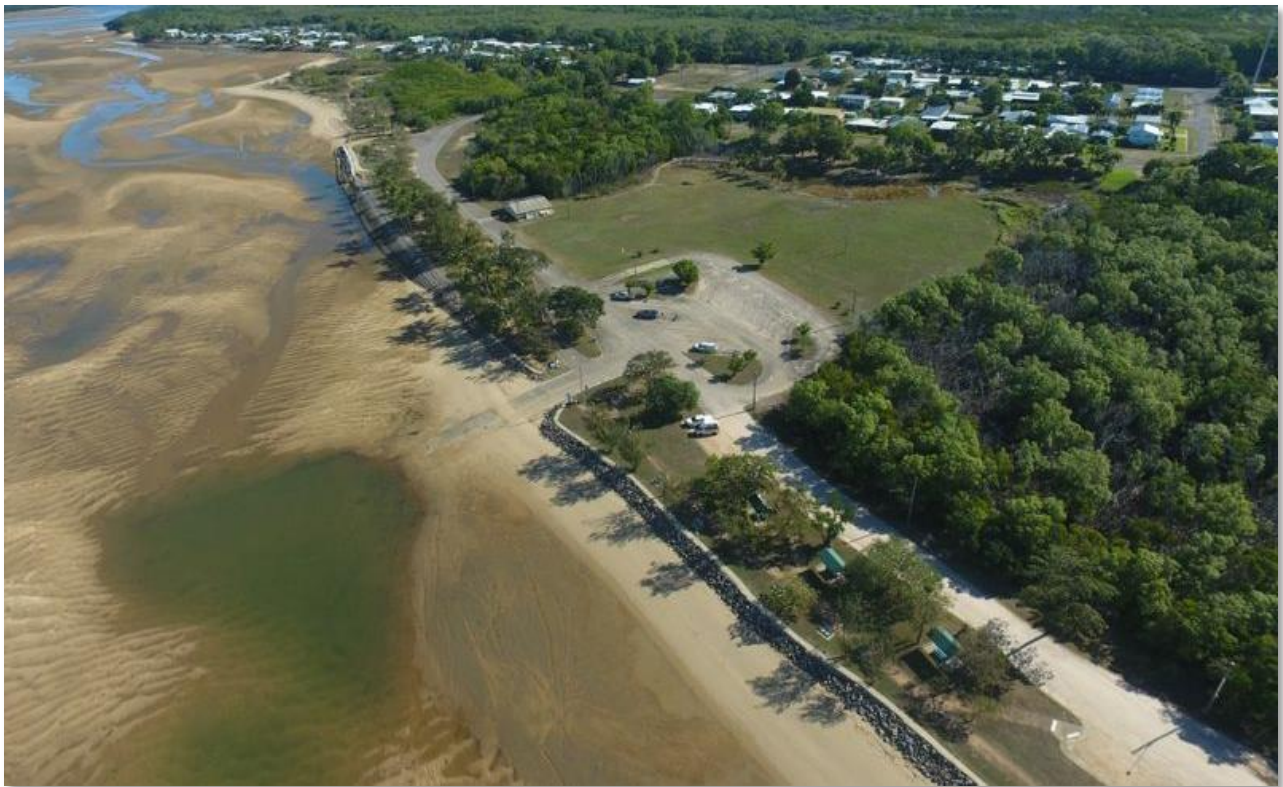
**Figure 4-9** Indicative dredge area at the Taylors Beach Boat Ramp

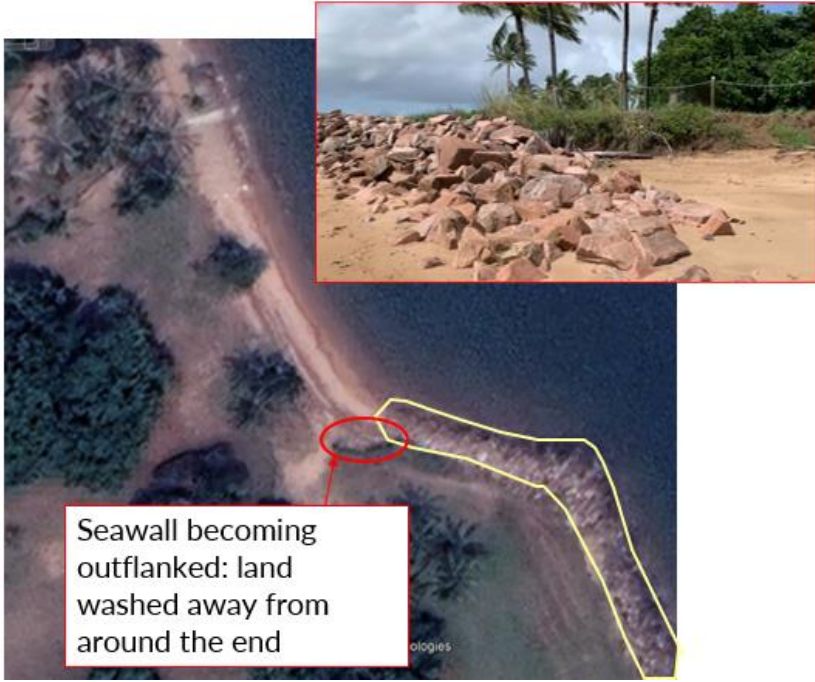
| Description and Rationale | | |
|---|--|--|
| <p>Seawall becoming outflanked: land washed away from around the end</p> | | |
| Figure 6-13 Seawall outflanking issues | | |

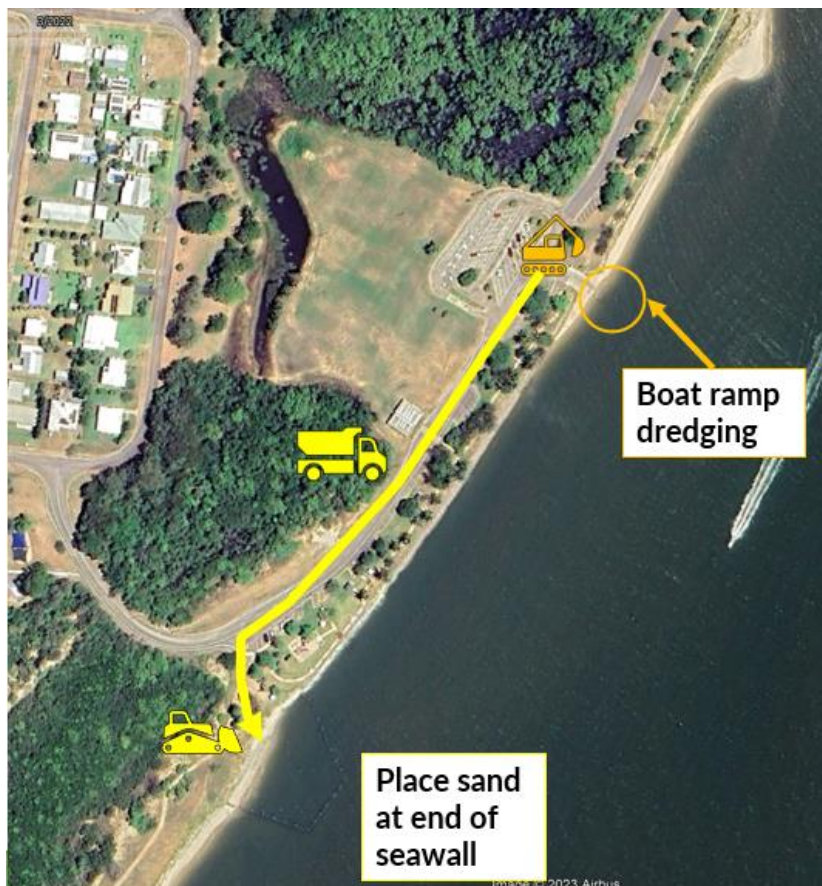
**Figure 6-17 Indicative arrangement of dredge material reuse at Taylors Beach**
